Initial Experience With a Technique for Wound Closure after Cardiac Device Implantation Designed to Reduce Infection and Minimize Tissue Scar Formation

Blair P. Grubb, MD,^{1*} Marlene Welch, MD, PhD,² Beverly Karabin, RN, PhD,¹ Warren Foster, MD,¹ Dong Zhang, MS,³ and Khalil Kanjwal, MD¹

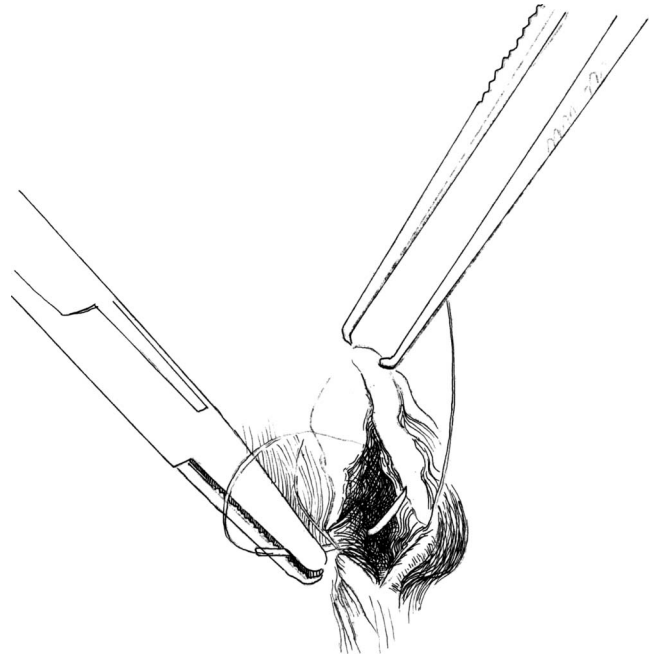
FIGURE 2. Position of the needle during the second half of the stitch placement: note that the needle is inserted superficially and exits deep into the tissue.

new or replacement) at our institution. All patients received preoperative intravenous antibiotics. After an initial sharp incision, meticulous blunt dissection was employed to either create (or reopen in case of replacement) a subfacial pocket. After cardiac device placement or replacement, the pocket was rinsed with an antibiotic solution, and the fascial layer was closed with a 2.0 absorbable braided polyfilament suture. The subdermal layer was then closed with a series of interrupted sutures using a 3.0 absorbable monofilament suture material (Fig. 1 and 2). Each of the sutures was approximately 5 mm apart from each other with the suture knot buried deep in the subcutaneous tissue (Fig. 3 and 4). The skin surface was then closed with surgical tissue adhesive (2-octyl cyanoacrylate), and the wound was dressed with a nonadherent gauze pad and a transparent adhesive film dressing. The patients were allowed to shower immediately after implantation if they so chose. The dressing was removed after 1 week. All patients were seen back in follow-up after 1-week, 1-month, and 3-month intervals at postimplant. Thereafter, patients were seen back in follow-up at 6-month intervals.

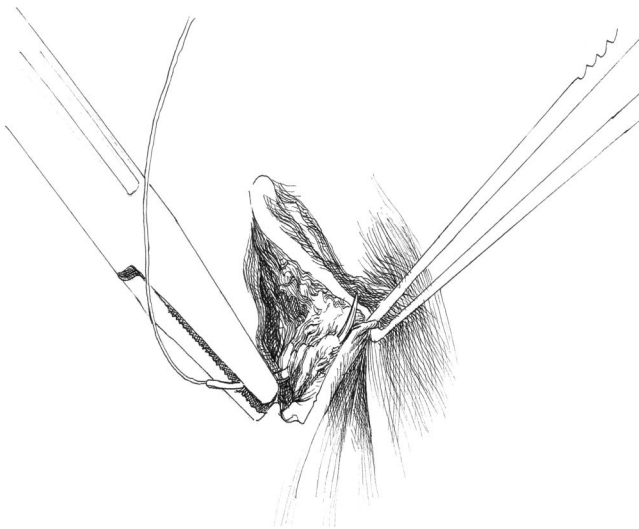
FIGURE 1. Position of the needle during the initial upward pass for the first pass of the stitch. Note that the needle is inserted deep into the tissue and exits superficially.

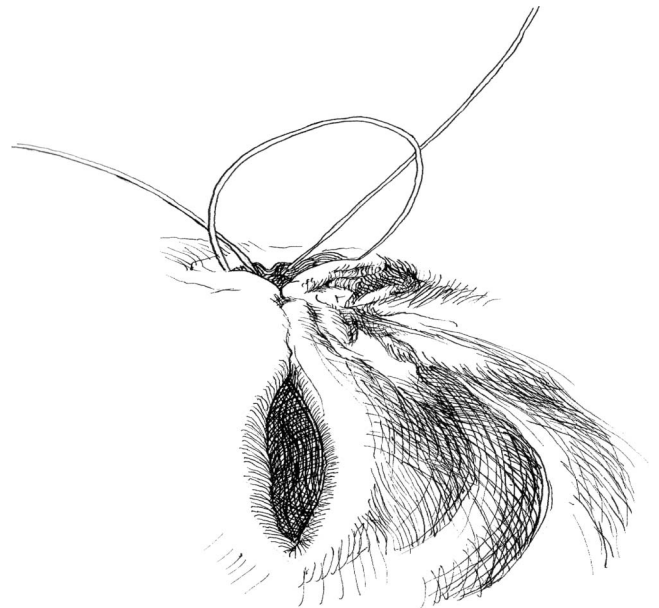
FIGURE 3. Position of the sutures before tying a knot to bury the knot-free strands must be on the same side.

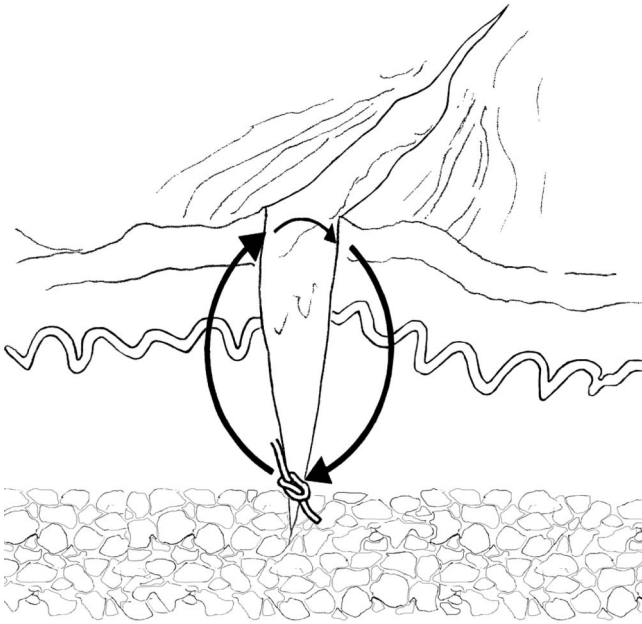
FIGURE 4. Final position of suture with buried knot.

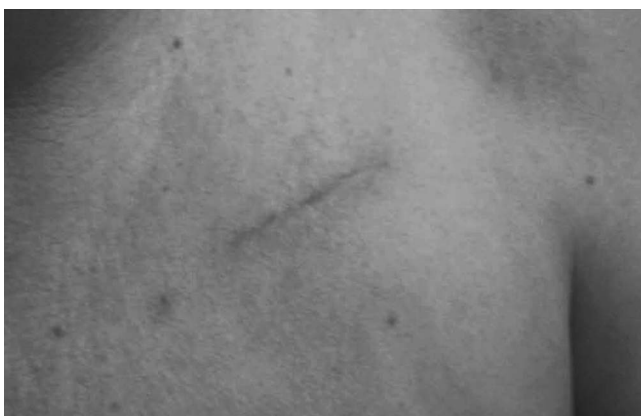
FIGURE 5. Final appearance of the wound at 2 months of follow-up.

showered within 24 hours of the procedure and during the first week afterward with no adverse effects noted. Each patient felt that the scar left over the pulse generator insertion site was cosmetically acceptable (Figure 5). There were no wound dehiscences observed.
